TJERNLUND PRODUCTS, INC.

MODEL (950-0625) SS1 REPLACEMENT MOTOR WITH WHEEL KIT INSTRUCTIONS

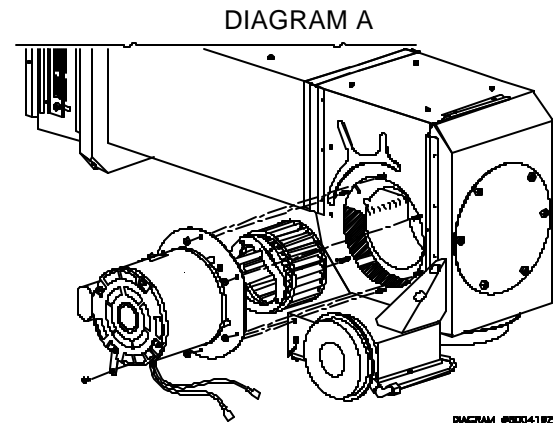
For the steps following below, refer to diagram A.

1. Remove electrical box cover and disconnect (2) motor leads.
2. Remove and save (1) motor bracket screw from electrical box.
3. Holding the motor, apply firm pressure towards the plenum of the SideShot and remove and save the (6) motor mount nuts. **Note: Hold the assembly firmly; failure to do so could damage internal parts.**

4. Slide motor/wheel assembly from Plenum. Grasp only the motor casing; do not damage wheel, shaft or other components on Plenum. Do not rest assembly on wheel.

5. Install new motor/wheel assembly into Plenum with leads facing electrical box. Use caution when inserting motor/wheel assembly into Plenum to avoid wheel damage. Firmly fasten motor to plenum using (6) nuts removed in step 3 above.

6. Route wires from motor into electrical box. Slip BLACK onto terminal "M" and WHITE onto terminal "L2" of terminal strip.
7. Reinstall (1) motor bracket screw removed from step 2 above.

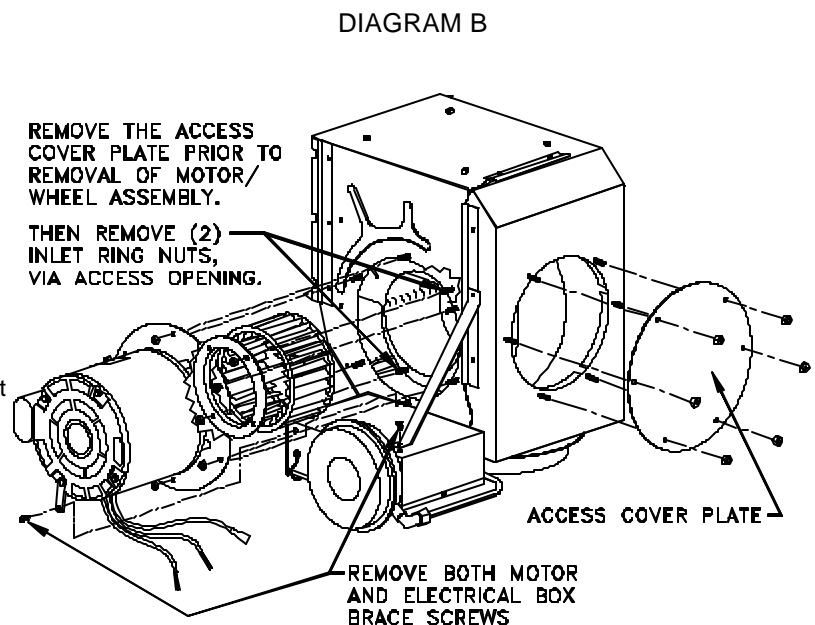
For the steps following below, refer to diagram B.

1. Remove electrical box cover and remove (3) motor leads.
2. Remove and save (2) motor & electrical box brace screws.
3. Remove and save (2) nuts from inlet collar on housing inside plenum. **Note:** Removal of plenum access cover plate will allow for removal of inlet collar nuts with 11/32" box end wrench.
4. Push down electrical box about 1/4" so motor mount plate can clear junction box. Once motor mount plate has cleared the studs it can be rotated so motor mount plate flat aligns up with junction box for easier removal.
5. Holding the motor, apply firm pressure towards the plenum of the SideShot and remove and save the (6) motor mount nuts. **Note:** An 11/32" box end wrench is used for nut directly under electrical box. **Note: Hold the assembly firmly; failure to do so could damage internal parts.**

- Slide motor/wheel assembly from Plenum. Grasp only the motor casing; do not damage wheel, shaft or other components on Plenum. Do not rest assembly on wheel.

For the steps following below, refer to diagram B.

- Install new motor/wheel assembly into Plenum with leads facing electrical box. Use caution when inserting motor/wheel assembly into Plenum to avoid wheel damage. Firmly fasten motor to plenum using (6) nuts removed in step 5.

- Replace plenum access cover plate and tighten (6) nuts removed in step 3.
- Reinstall motor and electrical box brace screws removed from step 2.
- Route BLACK and WHITE wires from motor into electrical box. **Note:** A ground wire is not included on these replacement motors. The motor is grounded by contact with the Plenum and ground wire from terminal strip to Plenum.

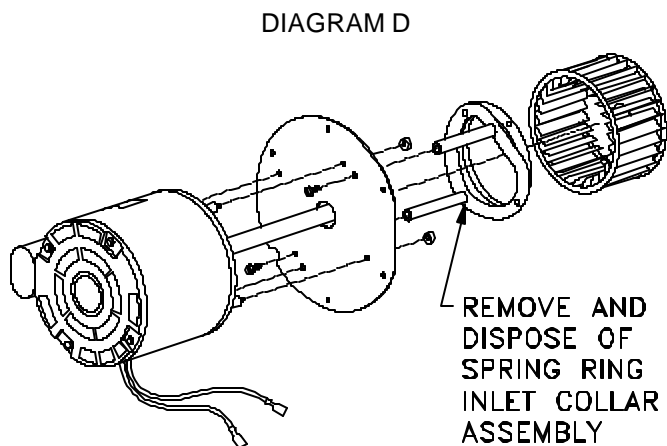
For the steps following below, refer to diagram D.

The new motor/wheel with spring ring inlet collar assembly is only compatible with SideShots with date codes after 9518. The following modifications will have to be made to adapt the motor/wheel assembly to the SideShot with date codes between 9226 and 9517.

- Loosen set screw with 5/32" allen wrench and remove wheel from new motor.
- Remove and save (4) nuts from the new motor mounting plate and remove from motor. Leave spacers on motor studs.
- Remove (2) screws which hold spring ring inlet collar assembly to mounting plate and discard spring ring inlet collar assembly.
- Secure motor to mounting plate with (4) nuts removed in step 10. **Important:** The capacitor of the motor should be opposite the flat edge on motor mounting plate.
- Place inlet collar removed in step 8 over new motor shaft so embossed edge will be facing wheel cavity, (See Diagram C).
